HDP SYSTEM A PYROS DID NOT DETONATE DURING STS-112 LAUNCH

Element/End Item: 104
Flow/Usage: **FLT28**
Facility: **OPF1**
Design Center Concurrence: **KSC**
Category:
OPR: **EPD**
TTL ORG: **SE**

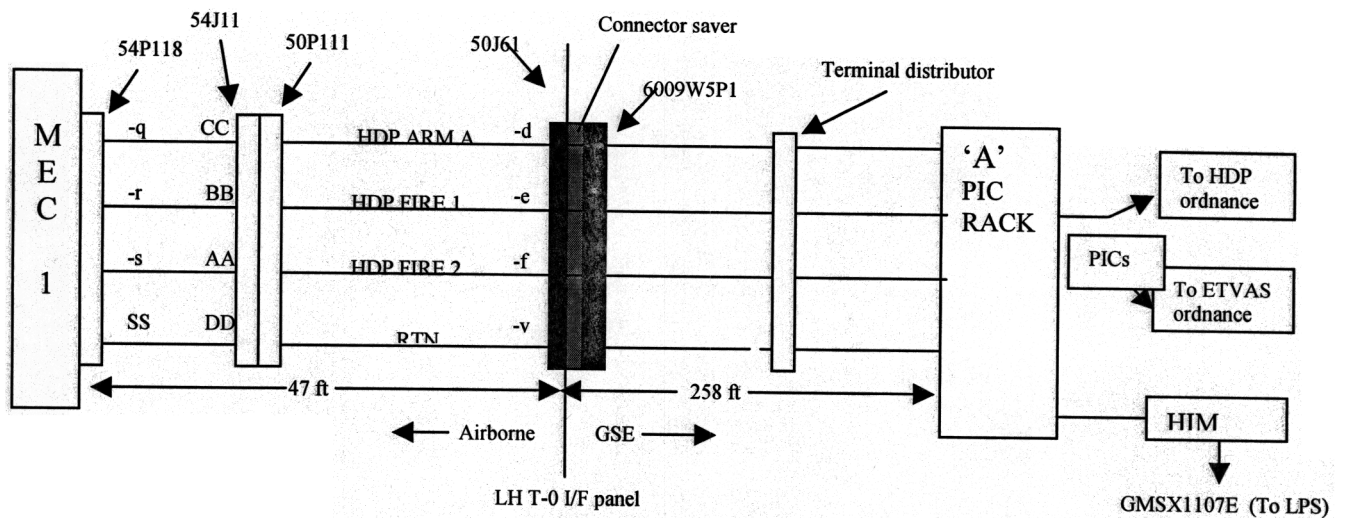
Just after T-0 during the launch of STS-112 on 10/07/02 at approximately 1545 ET, the GLS software in Firing Room 3 annunciated a 'cutoff' condition and did not automatically issue the normal post launch safing even though the vehicle had successfully left the mobile launch platform. Real time data review revealed that the erroneous GLS indication and subsequent safing hang-up was triggered by the failure of a MLP 3 GSE indication (GMSX1107E: SYS A HDP T-0 Bus On Indication) to transition from OFF to ON at T-0. Starting at T-2 seconds, GLS continuously monitors both the SYS A and SYS B HDP T-0 Bus On indications and requires that both (2 of 2) be ON as confirmation that liftoff has occurred and before it will issue post launch safing. More detailed post-launch data review then showed that the MLP 3 Hold Down Post (HDP), ET Vent Arm System (ETVAS) and ETVAS Lanyard 'A' circuit pyrotechnic devices did not receive detonation energy as expected from the MLP 3 system A PICs (Pyrotechnic Initiation Controller). The F1 and F2 switch indicators did not come on, indicating that the F1 and F2 commands were not processed by the PICs. Since the PIC rack did not see all three requisite commands in the proper sequence, it did not issue the detonation energy to the A circuit HDP or ETVAS ordnance. Of the three signals, only the ARM signal could be positively verified as reaching the PICs.

All three of these commands along with their return are routed from MEC1 (Master Events Controller, located in the aft of the Orbiter in avionics bay 4) to the MLP PIC rack (located in MLP compartment 7A) via separate, discrete sockets/wires in LH T-0 connector 50J61. The redundant 'B' circuits for the HDP and ETVAS pyrotechnics, which are issued at the same time as the 'A' commands, were unaffected at T-0 and did detonate the 'B' side pyros properly. Because of the redundant design of the HDP frangible nuts and the ETVAS bolt, there was still a 'clean' HDP and ETVAS mechanical release at T-0, and thus, a successful launch.
